## CITY OF BALTIMORE SMOKE TESTING OBSERVATION SUMMARY LOW LEVEL SEWERSHED

## BALTIMORE CITY PROJECT 1029 REI/DRAYCO

Unique Test ID: 571 Date: 08/27/2008 Basin: LL - 44 Manhole ID: S19K\_034MH Defect No: OB01 Supervisor: E.R. Crew: 04 Dye Test Recommended: N

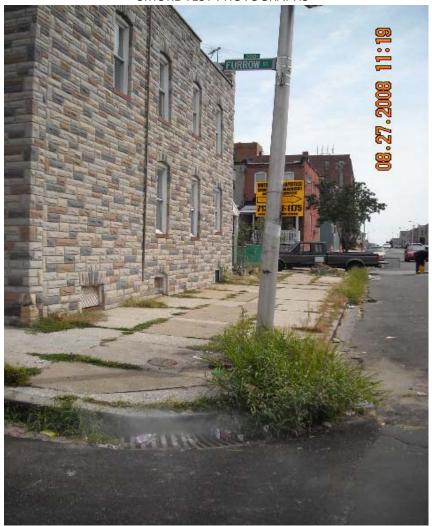
Photograph No: OB01-01 Filename: 1029-571\_OB01-01.jpg

Location: FURROW ST & MCHENRY ST

Source Type: 12 Catch Basin Sector: 01 Public

Location: 06 Curb Severity: 03 Moderate Drainage Area: 1800

Comments: STORM DRAIN AT CORNER OF FURROW ST. AND MCHENRY ST. IS SMOKING.
